DAMAGE PROFILES IN SILICON AND THEIR
IMPACT ON DEVICE RELIABILITY

International Business Machines Corporation
East Fishkill Laboratories
Hopewell Junction, New York 12533

Final Report
April 1, 1978

G. H. Schwuttke and K. H. Yang

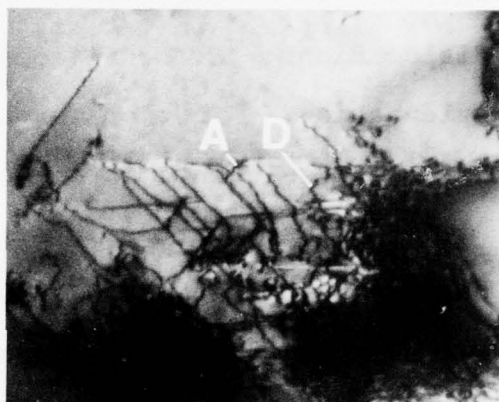
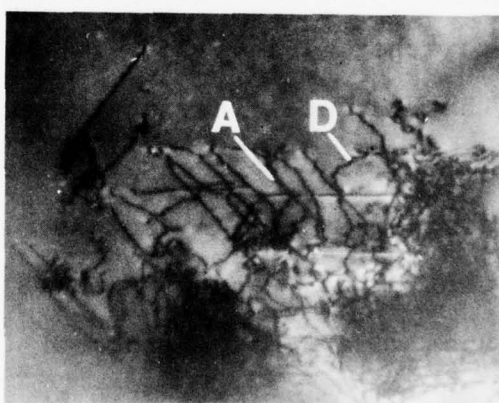
Fig. 3 Transmission electron micrographs showing dislocation movement during electron beam exposure. Dislocation loops A and D expand while B shrink. The interval of exposure time is about two seconds.

During the TEM investigations, the dislocations near a damage center were found to be unstable and to move easily during electron beam exposure. A sequence of such a dislocation movement is shown in Fig. 3. The exposure time

for the focused electron beam is in the interval of two seconds. Figure 3b shows that the dislocation loop designated A in Fig. 3a expands while loop B shrinks. Loop A continues to expand and loop B glides out to the surface in Fig. 3c. It should be noted that loop A and dislocation arrays C lying in the $(1\bar{1}1)$ plane have the same Burgers vector, $a/2[10\bar{1}]$, but of opposite sense. The opposite sense follows from the opposite curvature between loop A and dislocations C. Dislocations C are close to screw orientation. Further expansion of loop A causes it to arrange itself into three segments in $\langle 110 \rangle$ directions, Fig. 3c. One segment is in screw orientation and the other two make an angle of 60° with the Burgers vector. Once the screw segment moves close enough to one dislocation in C, the attraction force between the two parallel screw dislocations of opposite Burgers vector tends to bind them together, Fig. 3d. The 60° segments finally glide out to the surface leaving the screw segment in place, Fig. 3e,f. It can also be seen in these figures that loop D undergoes a similar expansion process. The dislocation configuration of dislocation arrays A and B in Fig. 2c are best described by such an expansion process.

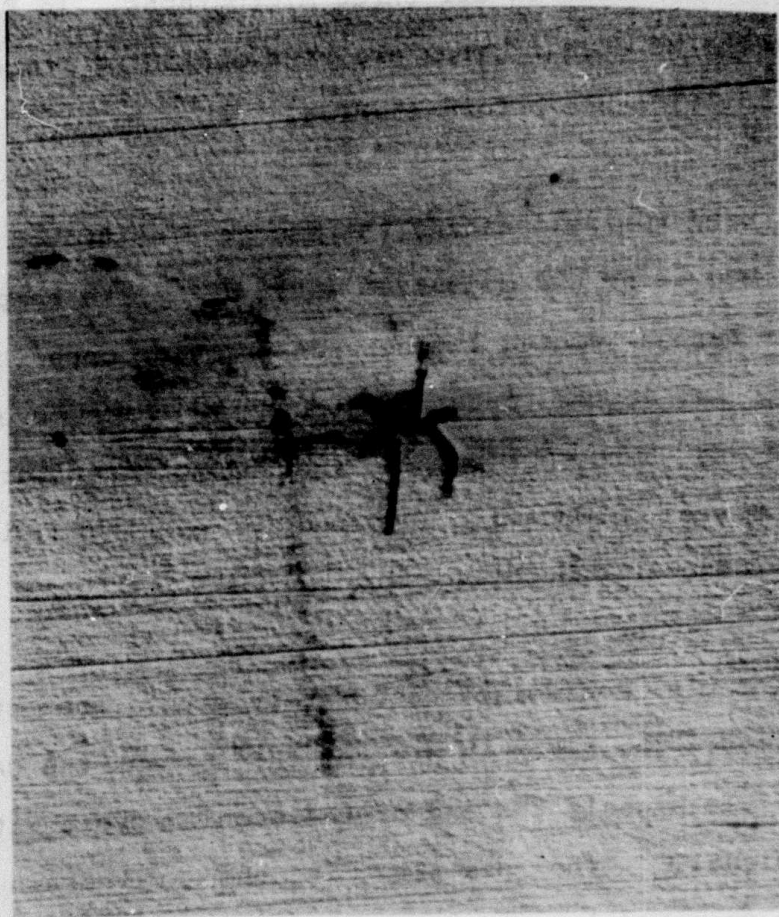
Fig. 2d. Closeup view (320X magnification) of etch figure indicated by arrow in Fig. 2c due to damage site located by arrows in Figs. 2a and 2b.

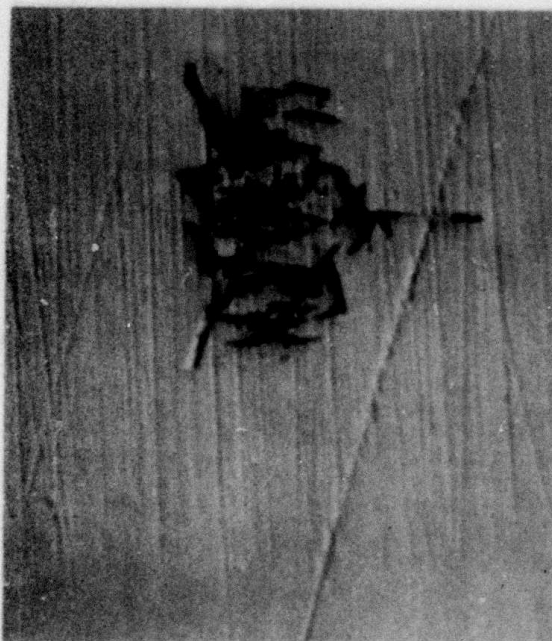
Fig. 3b-2. Etch figure due to ISS damage.
1390X magnification.

shown magnified in detail in Fig. 3b. Etch Figs. 1, 3, and 7 (Figs. 3b-1, 3b-3, and 3b-7) are not due to ISS induced damage. The remaining four etch figures are typical of etched ISS induced damage and are thus identified. The long etched out grooves are due to fractures and the short feathery ones are etched dislocation chains. Figures 3b-2, 3b-4, and 3b-6 are good examples. The two lower micrographs in Figs. 3b-4 are SEM recordings. The lower one gives a closeup view clearly showing the etched grooves. The lower micrograph in Figs. 3b-6 gives gives another such example. The upper edges of the fractures seen in the SEM micrograph of Figs. 3b-5 appear broken away. This may have occurred during bevelling.

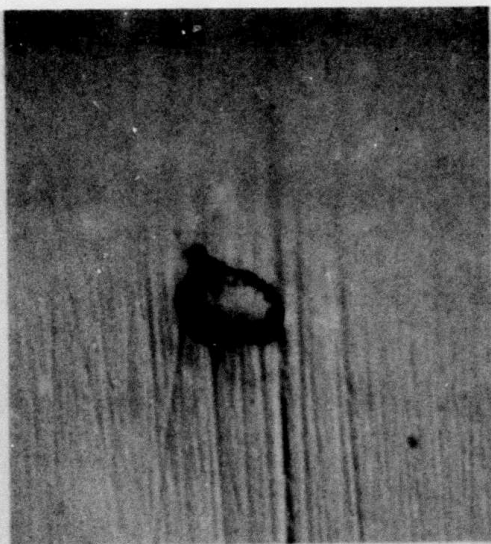
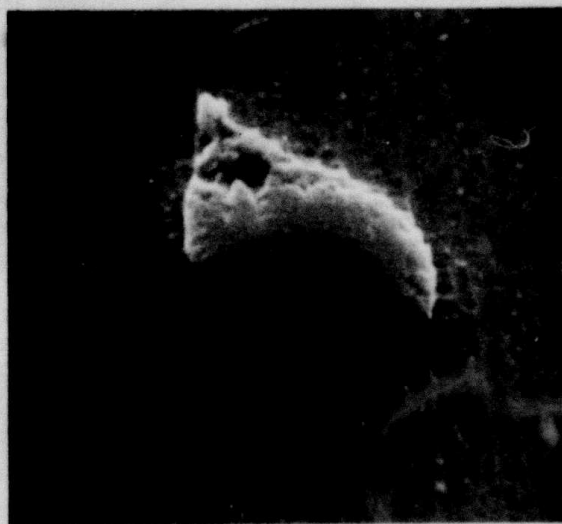
Light optical micrograph, 1390X magnification.

SEM micrograph, 4.7 KX magnification.

Fig. 3b-3. Particle on etched bevel.

Etch Fig. 1, at high magnification, is seen to be a shallow surface disturbance atypical of ISS damage. Etch Figs. 3 is identified in the SEM micrograph as a form protruding from the surface. It may be an imbedded aluminum oxide particle carried to its site in the abrasive slurry during bevelling. The SEM micrograph in the lower portion of Figs. 3b-7 shows that etch Fig. 7 has none of the typical etched grooves of ISS damage. It may be due to surface contamination.

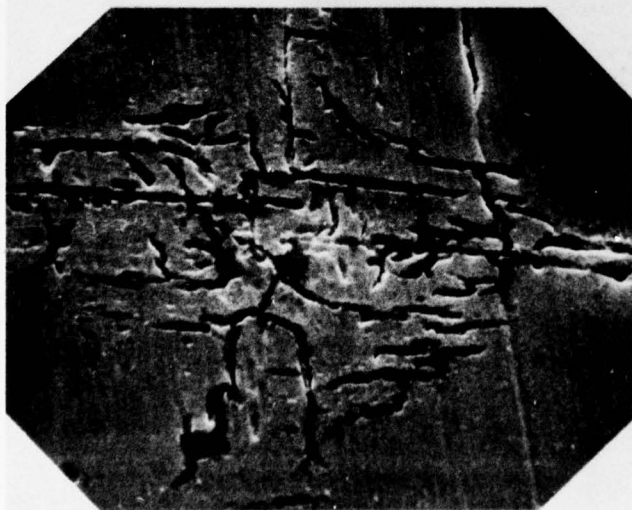
Light optical micrograph;
900X magnification.

SEM micrograph; 940X magnification.

Central view of etch figure
shown above;
3.2KX magnification.

Fig. 3b-4. Etch figure due to ISS damage.

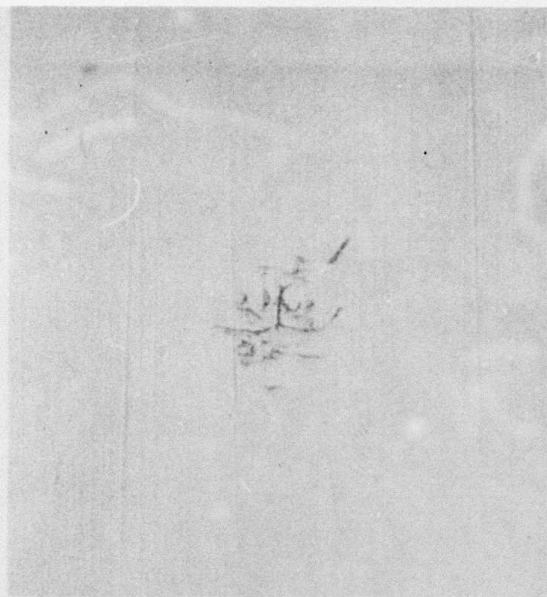
Light optical micrograph; 900X magnification.

SEM micrograph; 3.2 KX magnification.

Fig. 3b-6. Etch figure typical of ISS damage.

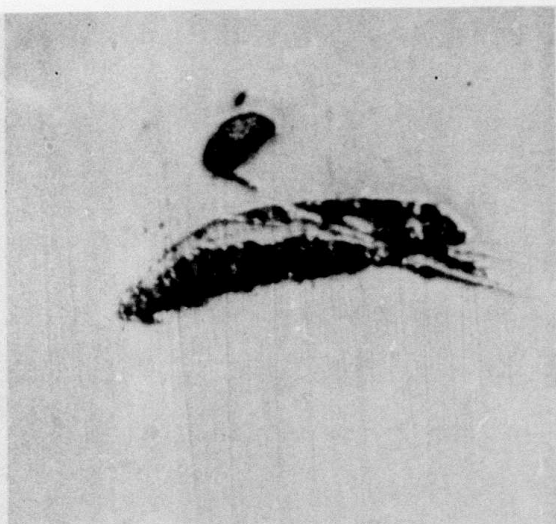
Light optical micrograph; 855X magnification.

SEM micrograph; 900X magnification.

Fig. 3b-7. Etch figure not due to ISS damage. Possibly caused by surface contamination.
